6
Ind-
National Dam Inspection Program. Twin
Lakes Number 1 Dam (NDS PA-00487,
Pennder 65-42), Ohio River Basin, Little
Crabtree Creek, Westmoreland County,
Pennsylvania. Phase I Inspection
Report.

TWIN LAKES NO. 1 DAM

PHASE I INSPECTION REPORT
NATIONAL DAM INSPECTION PROGRAM

11 APR 1979

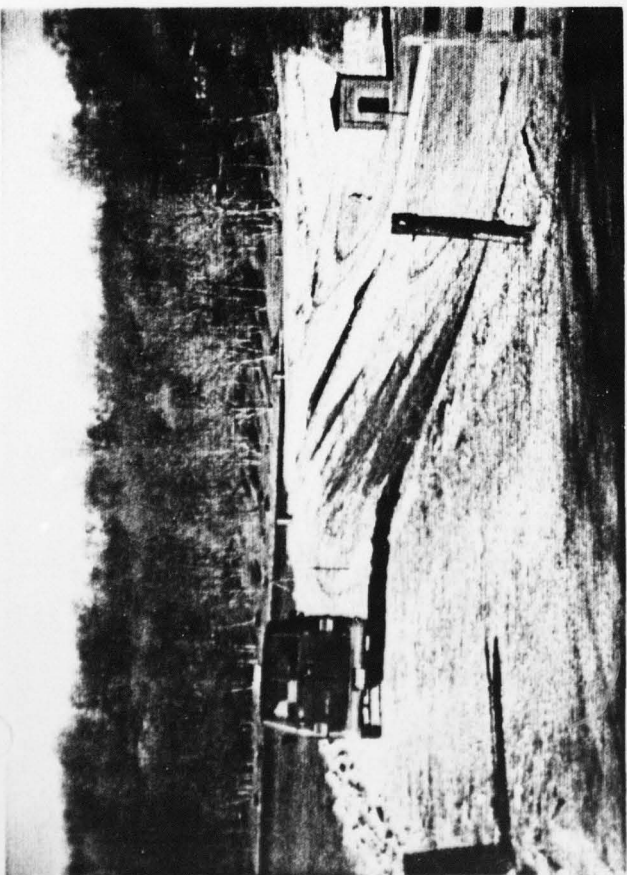
b. Embankment. The visual inspection suggests the embankment to be in good condition. Minor seepage, however, was observed along the downstream toe, particularly to the right of the spillway section (see Photograph 3). Despite the localized saturated areas, no signs of sloughing, erosion, or free flowing water were observed on or immediately below the embankment. A slag-gravel roadbed protects the crest against damage from occasional vehicular use. The downstream slope is covered with grass that requires little maintenance other than occasional mowing (see Photograph 1). The riprap is durable and well graded and provides adequate slope protection.

PHOTOGRAPH 1 View looking west along the crest and downstream slope of the embankment.
